HAZARDOUS PROCESS SERIES (u/s 2(cb) of Factories Act, First Schedule and Schedule-4 of 68-J)

ALKYLATION

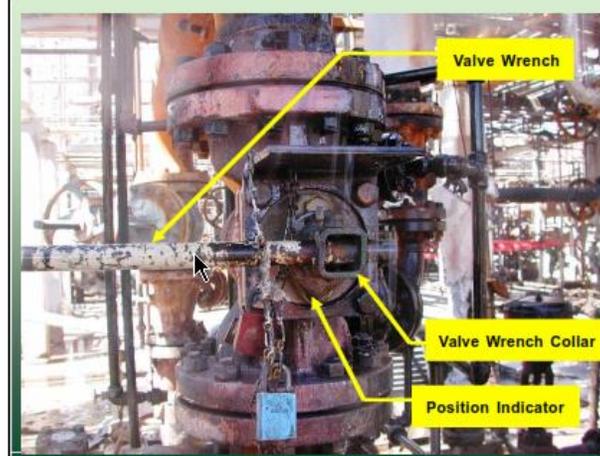
The spare pump was scheduled for maintenance. To isolate the pump for work, plant personnel, using a valve wrench, turned a shut-off valve connecting the pump to a distillation column to what they believed was the "closed" position. Investigators determined that the valve was actually open. An operator disconnected the pump's vent hose to verify that no pressure was in the pump, and witnessed some alkylate flow through the hose. After the flow subsided, he believed that the pump had been de-pressurized and was ready for removal.

The study concluded that the vent line was plugged, not de-pressurized. As the mechanics were removing the pump alkylate was suddenly released at high pressure and temperature, producing a loud roar that was audible throughout the refinery.

Suction Valve and Position Indicator as Found After Incident

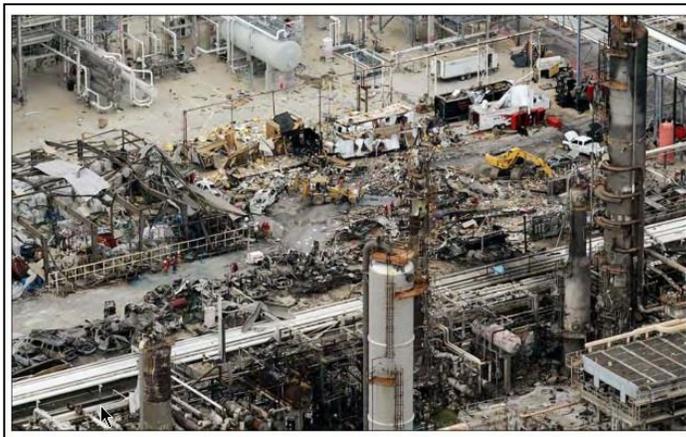
The raffinate splitter tower in the refinery's ISOM unit was restarted after a maintenance outage. During the startup, operations personnel pumped flammable liquid hydrocarbons into the tower for over three hours without any liquid being removed, which was contrary to startup procedure instructions. Critical alarms and control instrumentation provided false indications that failed to alert the operators of the high level in the tower. Consequently, unknown to the operations crew, the 170-foot (52-m) tall tower was overfilled and liquid overflowed into the overhead pipe at the top of the tower.

The overhead pipe ran down the side of the tower to pressure relief valves located 148 feet (45 m) below. As the pipe filled with liquid, the pressure at the bottom rose rapidly from about 21 pounds per square inch (psi) to about 64 psi. The three pressure relief valves opened for six minutes, discharging a large quantity of flammable liquid to a blow down drum with a vent stack open to the atmosphere. The blow down drum and stack overflowed with flammable liquid, which led to a geyser-like release out the 113-foot (34 m) tall stack. This blow down system was an antiquated and unsafe design; it was originally installed in the 1950s, and had never been connected to a flare system to safely contain liquids and combust flammable vapor released from the process.

The released volatile liquid evaporated as it fell to the ground and formed a flammable vapor cloud. The most likely source of ignition for the vapor cloud was backfire from an idling diesel pickup truck located about 25 feet (7.6 m) from the blow down drum. The 15 employees killed in the explosion were contractors working in and around temporary trailers that had been previously sited by BP as close as 121 feet (37 m) from the blow down drum.
